INDOOR AIR QUALITY ASSESSMENT

**Burbank Elementary School
266 School Street
Belmont, Massachusetts**

Prepared by:
Massachusetts Department of Public Health
Center for Environmental Health
Bureau of Environmental Health Assessment
Emergency Response/Indoor Air Quality Program
May 2004

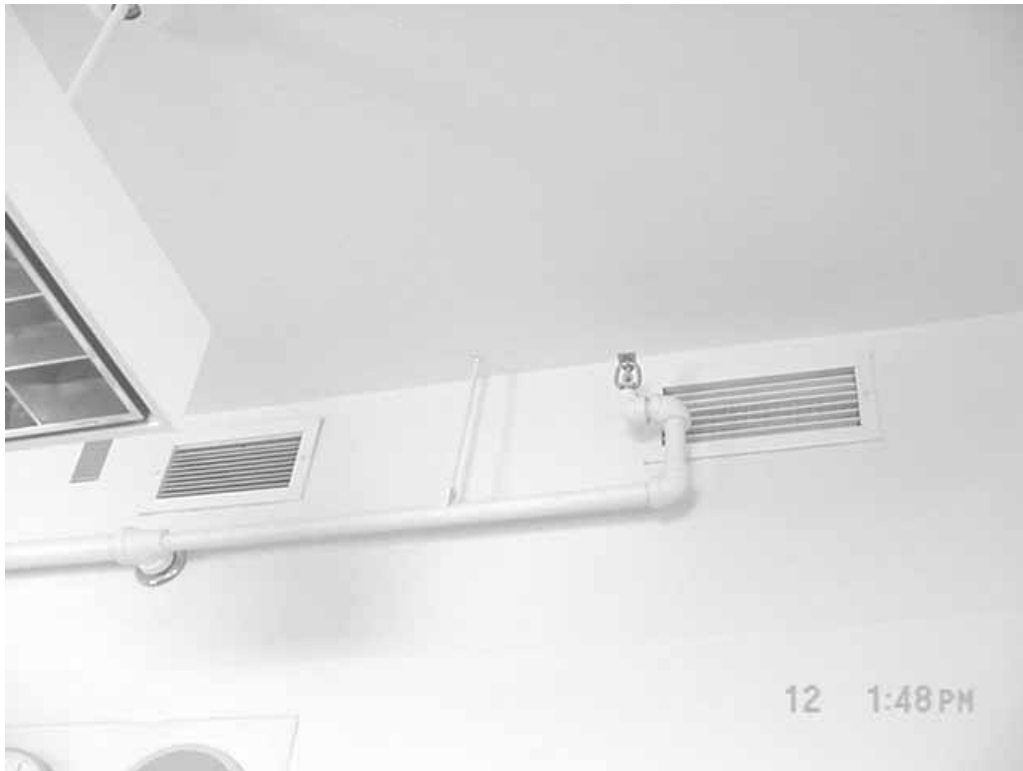
Picture 1

It can be seen from Table 1 that carbon dioxide levels were elevated above 800 parts per million parts of air (ppm) in eleven of twenty-nine areas surveyed, indicating inadequate air exchange in a number of areas. Mechanical ventilation is provided by air-handling units (AHUs) located in mechanical rooms and connected to ceiling or wall-mounted air diffusers via ductwork (Picture 1). Return air is drawn into wall or ceiling exhaust vents ducted back to the AHU (Picture 2). Exhaust vents were off or drawing weakly in several areas during the assessment (Table 1). Without the exhaust system operating as designed, normally occurring pollutants cannot be removed allowing them to build up and lead to indoor air quality/comfort complaints.

Wall-Mounted Supply Vents

4. Operate both supply and exhaust ventilation continuously during periods of school occupancy, independent of classroom thermostat control to maximize air exchange. Consult the school’s heating, ventilation and air conditioning (HVAC) engineer concerning an increase in the introduction of outside air.

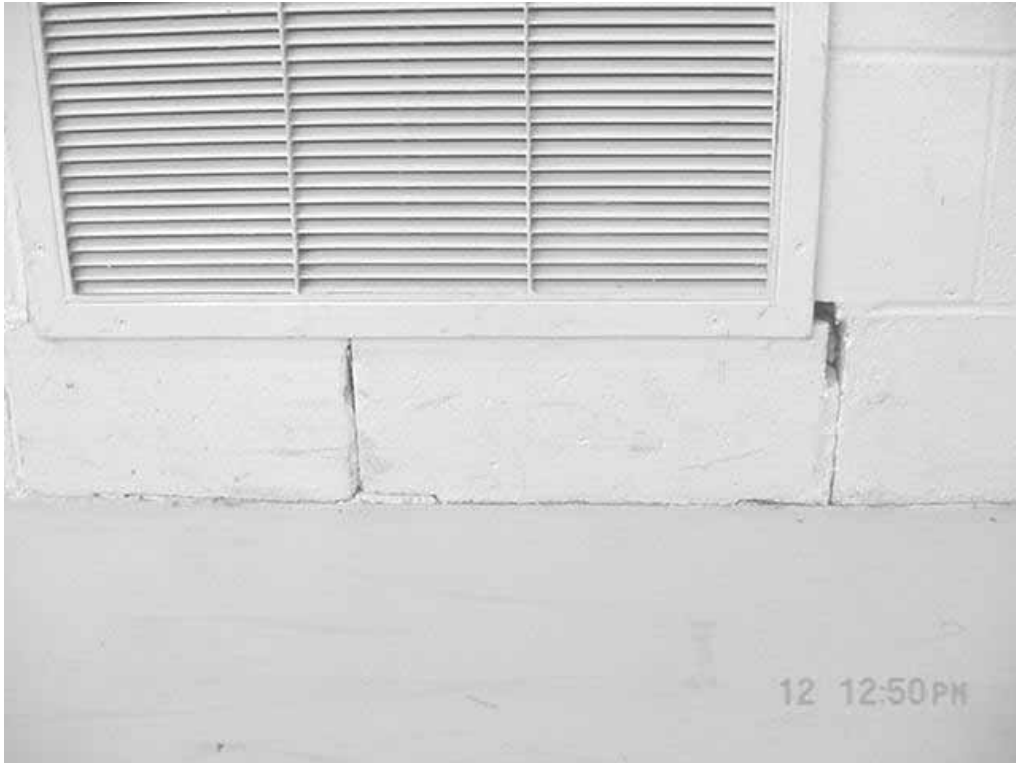
Picture 2

A number of exhaust/return vents were noted with accumulated dust. If exhaust vents are not functioning, backdrafting can occur, which can re-aerosolize accumulated dust particles. Also of note was the amount of materials stored in some classrooms. Items were observed on windowsills, tabletops, counters, bookcases and desks. The large number of items stored in classrooms provides a source for dusts to accumulate. These items, (e.g., papers, folders, boxes) make it difficult for custodial staff to clean. Items should be relocated and/or be cleaned periodically to avoid excessive dust build up. Dust can be irritating to eyes, nose and respiratory tract.

Wall-Mounted Exhaust/Return Vent

5. Ventilation industrial standards recommend that mechanical ventilation systems be balanced every five years (SMACNA, 1994).
6. Inspect exhaust/return system for proper function. Make repairs/adjustments as necessary.

14. Clean exhaust/return vents periodically to prevent excessive dust build-up.
15. Install door sweep and/or weather stripping around boiler room door to prevent the migration of odors into adjacent areas.

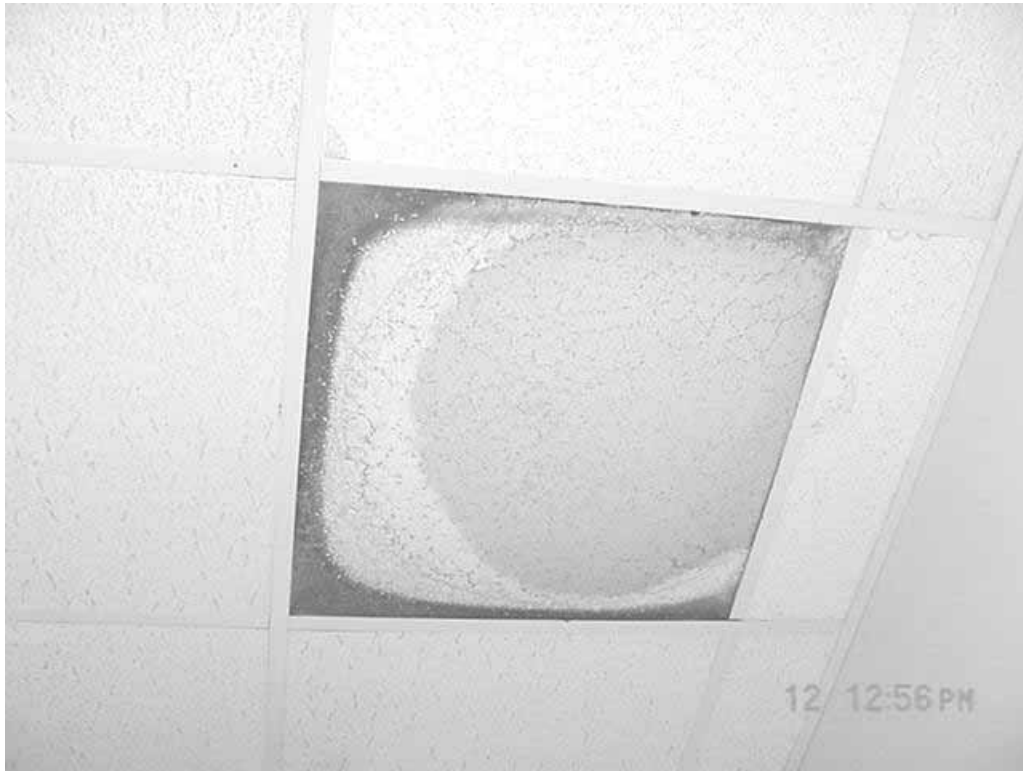
Picture 3

A few areas had water-damaged ceiling tiles, which can indicate leaks from the roof or plumbing system (Table 1). Water-damaged ceiling tiles can provide a source of mold and should be replaced after a water leak is discovered and repaired. BEHA staff identified a wet ceiling tile in room 204, which was reported by BES staff to have a history of roof leaks (Picture 3). Classroom 112 contained several water damaged ceiling tiles (Picture 4). BEHA staff examined conditions above the ceiling plenum and found no signs of leakage, mold growth or associated odors. The water damage appeared to be a result of condensation forming on uninsulated pipes rather than roof or plumbing leaks (Picture 5).

Water Damaged Ceiling Tile in Room 204 (Wet During Assessment on 12/12/2003)

8. Replace water damaged ceiling tiles. Insulate pipes above ceiling tiles to prevent condensation and further water damage.
9. Seal holes/breaches in the building envelope to prevent water penetration and pests. Consider having brick re-pointed.

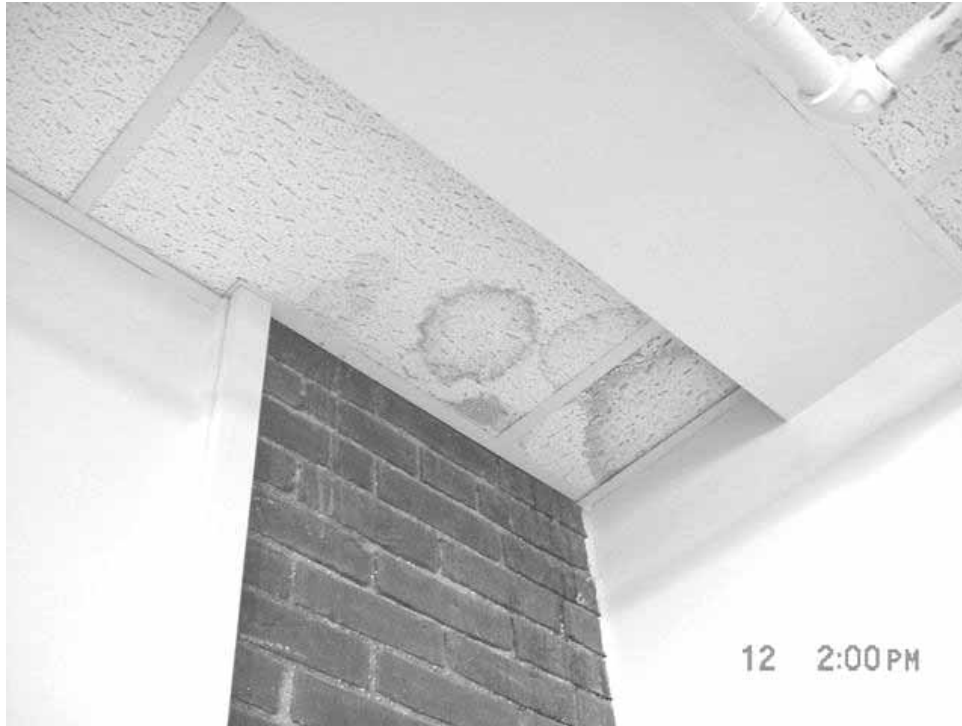
Picture 4

Water Damaged Ceiling Tiles in Classroom 112

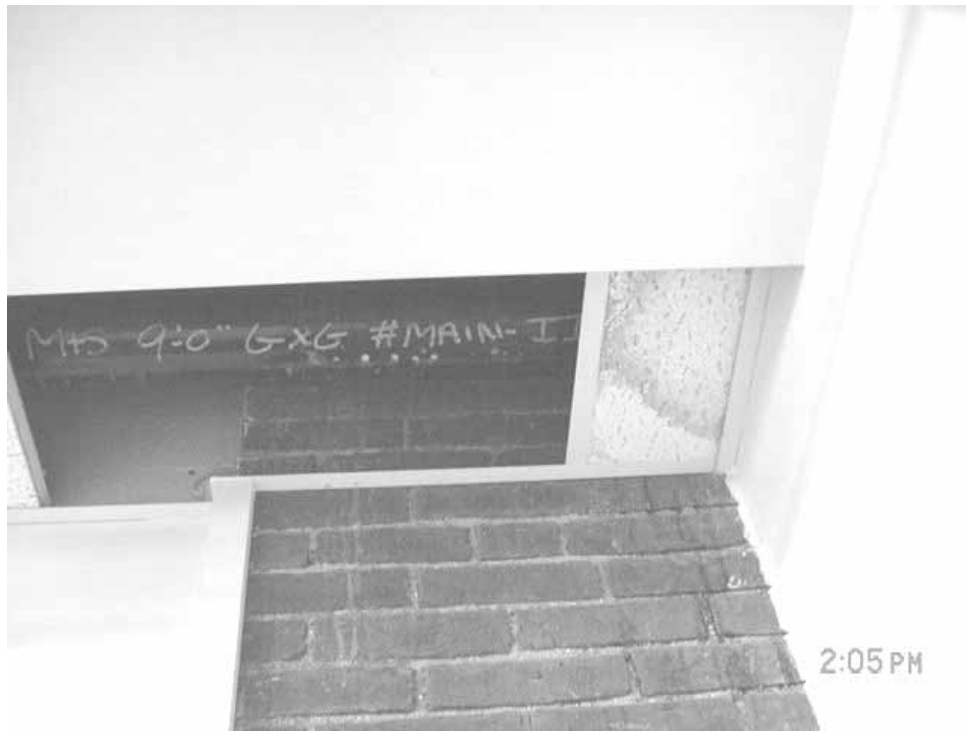
Picture 5

Uninsulated Pipe above Water Damaged Ceiling Tiles in Picture 4

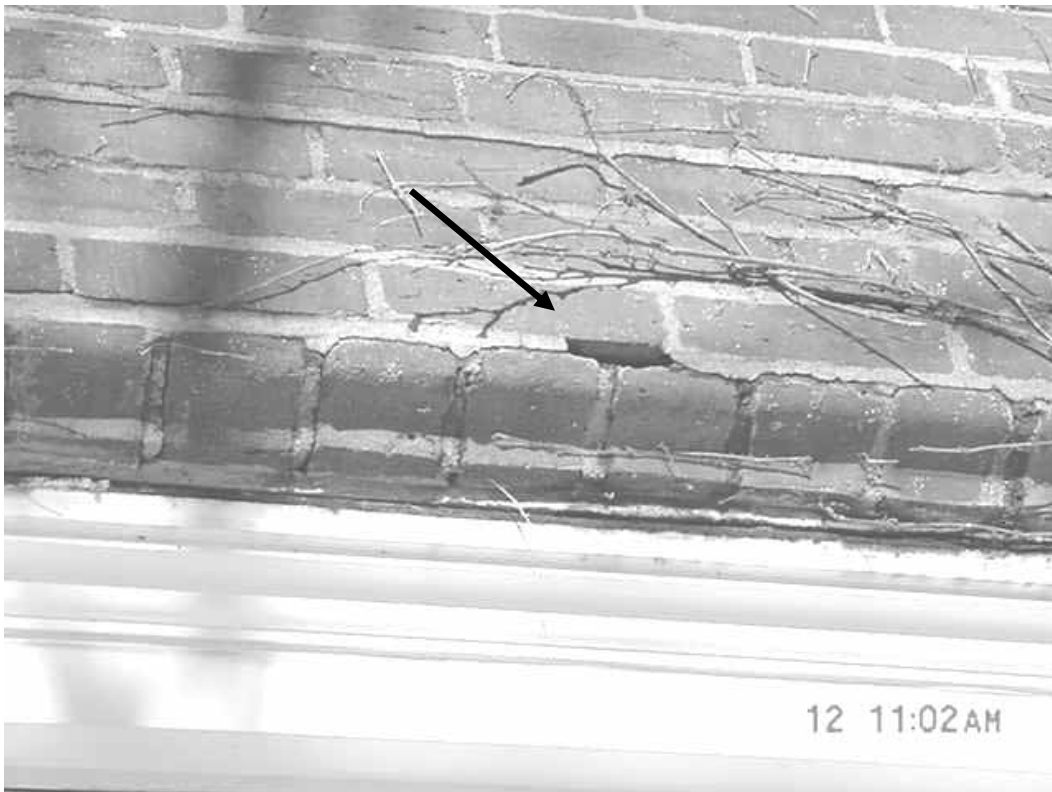
Picture 6

- Holes/spaces were observed in exterior brick where mortar is missing/damaged (Pictures 6 and 7).
- Spaces and missing/damaged caulking were observed around window frames (Picture 8).
- Efflorescence was observed on the walls of the cafeteria (Picture 9).

Missing/Damaged Mortar around Brick

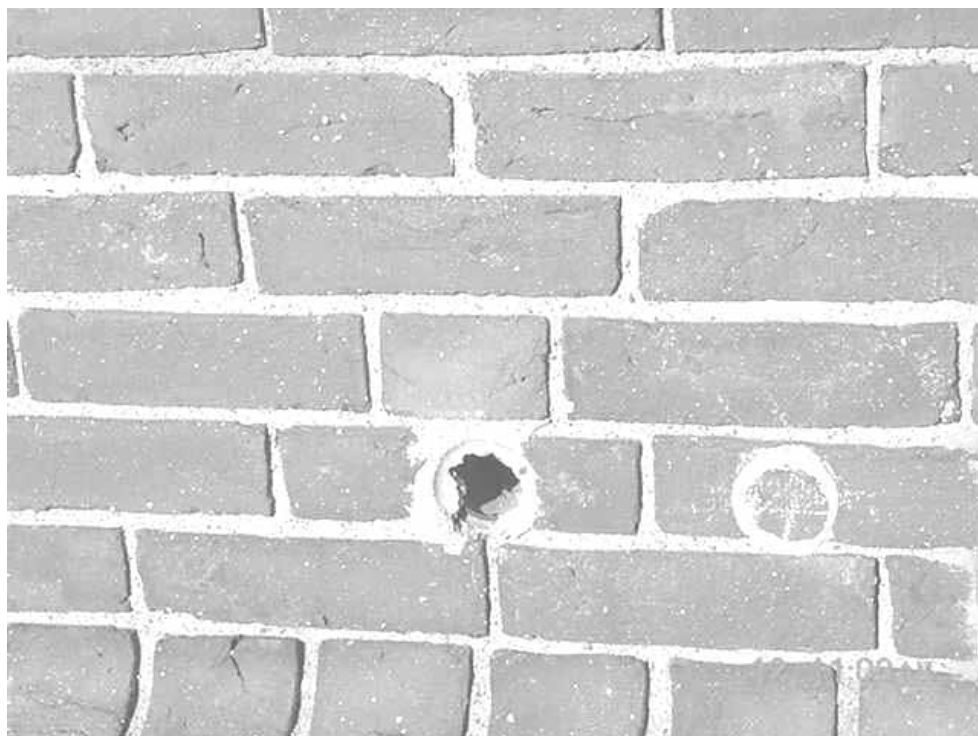
Picture 7

Open Hole in Exterior Brick

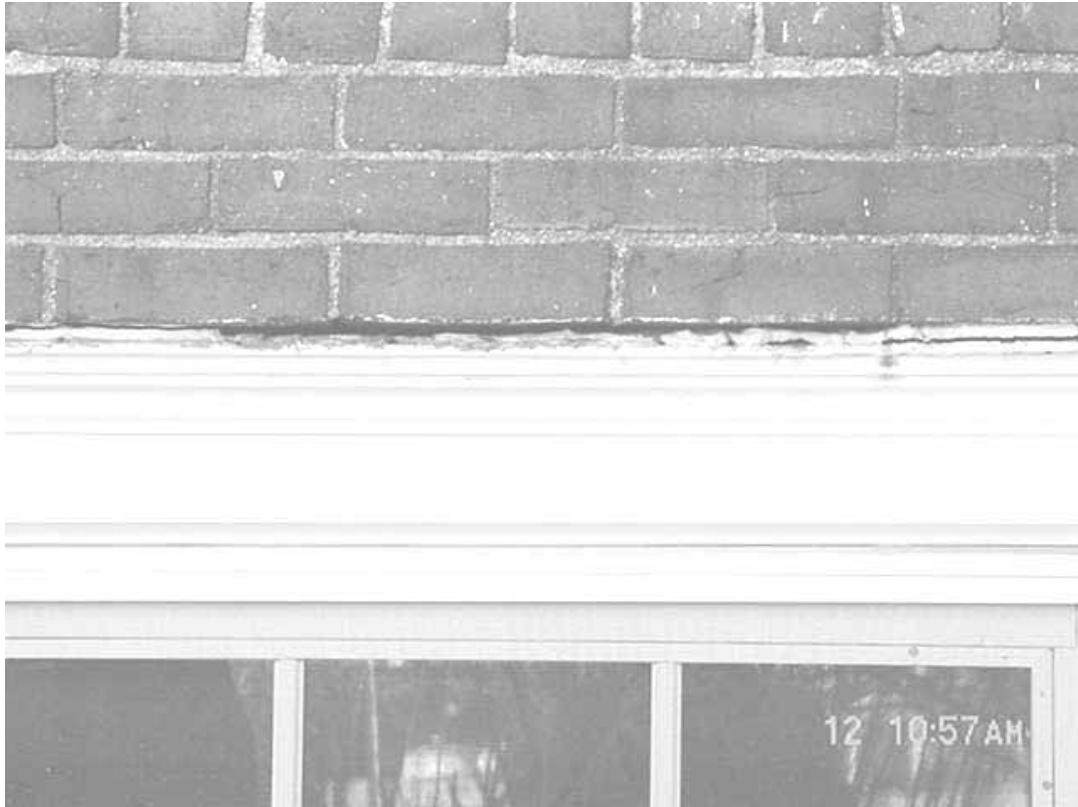
Picture 8

Missing/Damaged Caulking around Window Frame

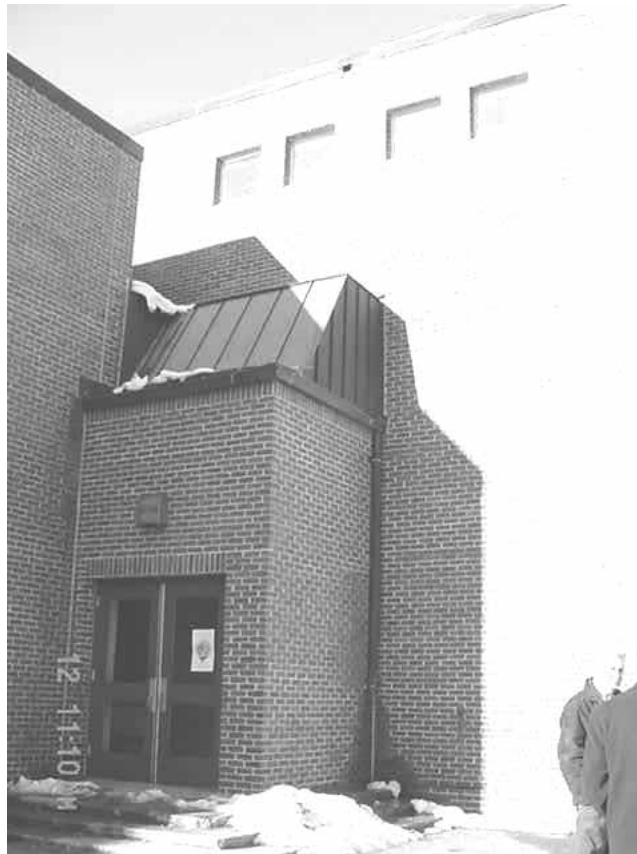
Picture 10

Efflorescence is a characteristic sign of water damage to building materials such as brick or plaster, but it is not mold growth. As moisture penetrates and works its way through mortar and brick, water-soluble compounds dissolve, creating a solution. As the solution moves to the surface of the brick or mortar, water evaporates, leaving behind white, powdery mineral deposits. This condition indicates that water from the exterior has penetrated into the building. In this case, the most likely source of water penetration is infiltration along flashing between building surfaces [(i.e., the metal roof and brick wall) (Picture 10)].

Building Interface, Area of Potential Water Infiltration around Flashing

10. Work with a building contractor to identify and repair leaks around flashing (Picture 10).
11. Remove leaves and debris from subterranean pits seasonally.

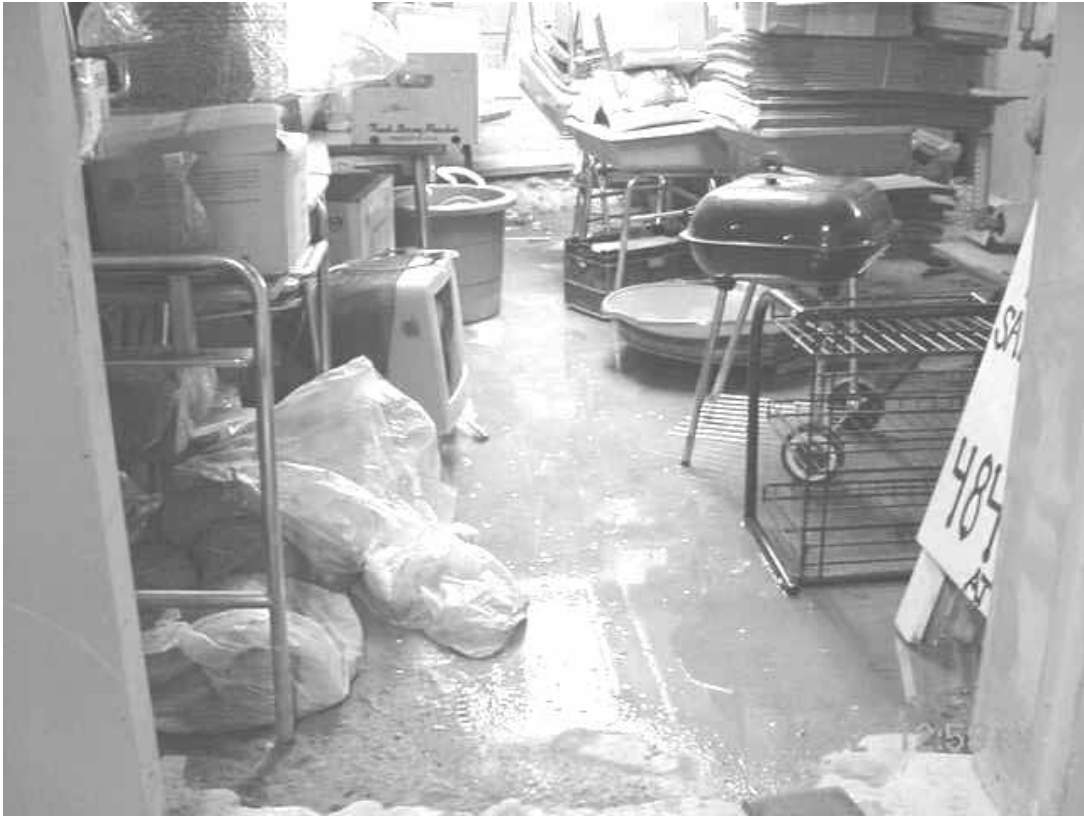
Picture 11

Other sources of moisture and or potential mold growth were observed in the building. Standing water was observed in the ground floor mechanical room (Picture 11). The mechanical room was being used for storage of porous items, including cardboard boxes and paper. A number of items were visibly water damaged. Prolonged moistening of cardboard or paper can result in mold growth in these materials.

Standing Water in Mechanical Room, Note Storage of Materials

1. Remove water damaged porous materials from mechanical room and refrain from using as storage space. Disinfect any areas of microbial growth with a one in ten bleach in water solution; wipe clean surfaces with soap and water after disinfection. Ensure HVAC system is deactivated prior to any cleaning activities.

2. Contact a building engineer and/or building envelope specialist to examine means to prevent water infiltration into lower level areas.
3. Consult “Mold Remediation in Schools and Commercial Buildings” published by the US EPA (US EPA, 2001) for further information on mold and/or mold clean up. Copies of this document are available from the US EPA at:
http://www.epa.gov/iaq/molds/mold_remediation.html.

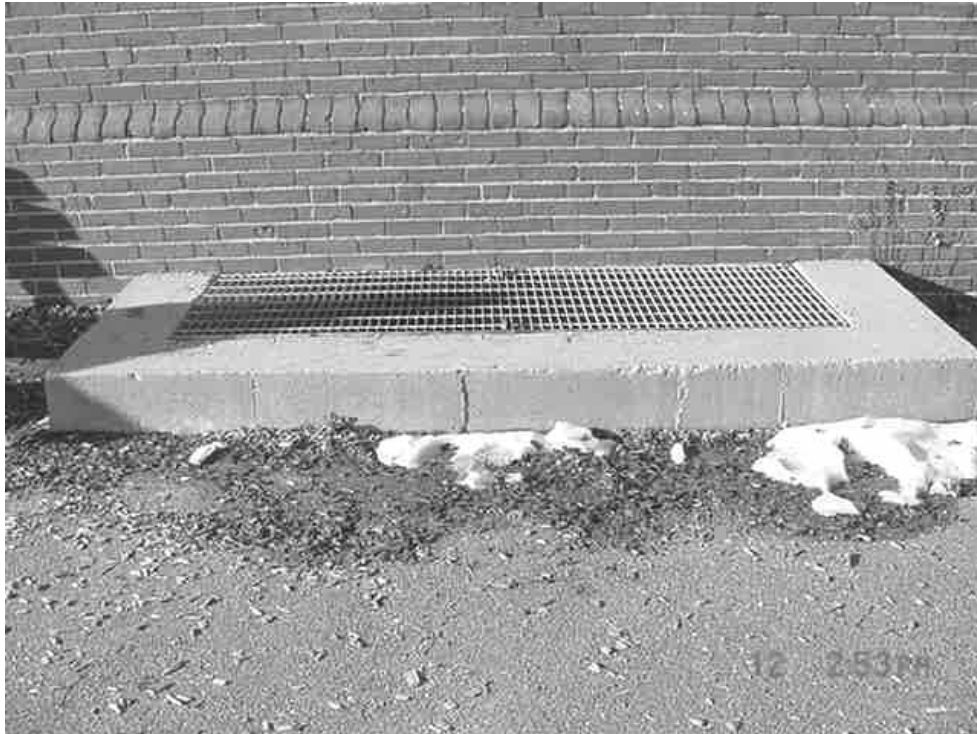
Picture 12

Several subterranean pits were located along the perimeter of the building (Picture 12). These pits allow airflow into below grade air intakes for the mechanical ventilation system. Leaves, papers and other debris were observed on the floor of the pits (Picture 13), which can

Subterranean Pit for Air Intake

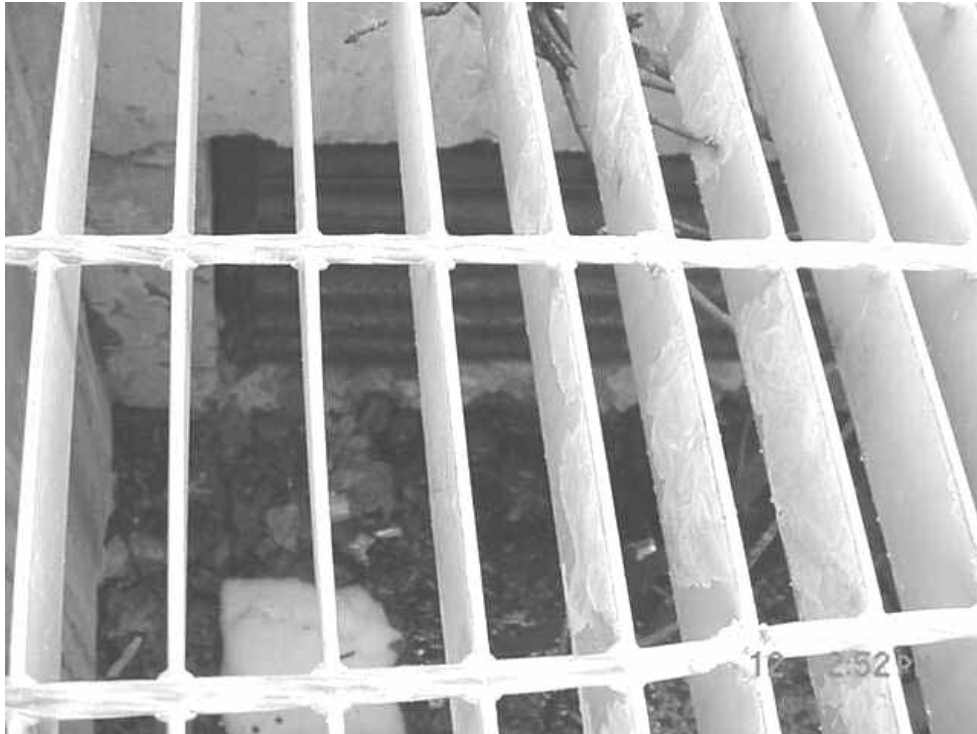
Picture 13

also provide a source of mold growth. Mold odors and growth can subsequently be entrained into the ventilation system.

Leaves, Plants and Other Debris in Subterranean Intake Pit

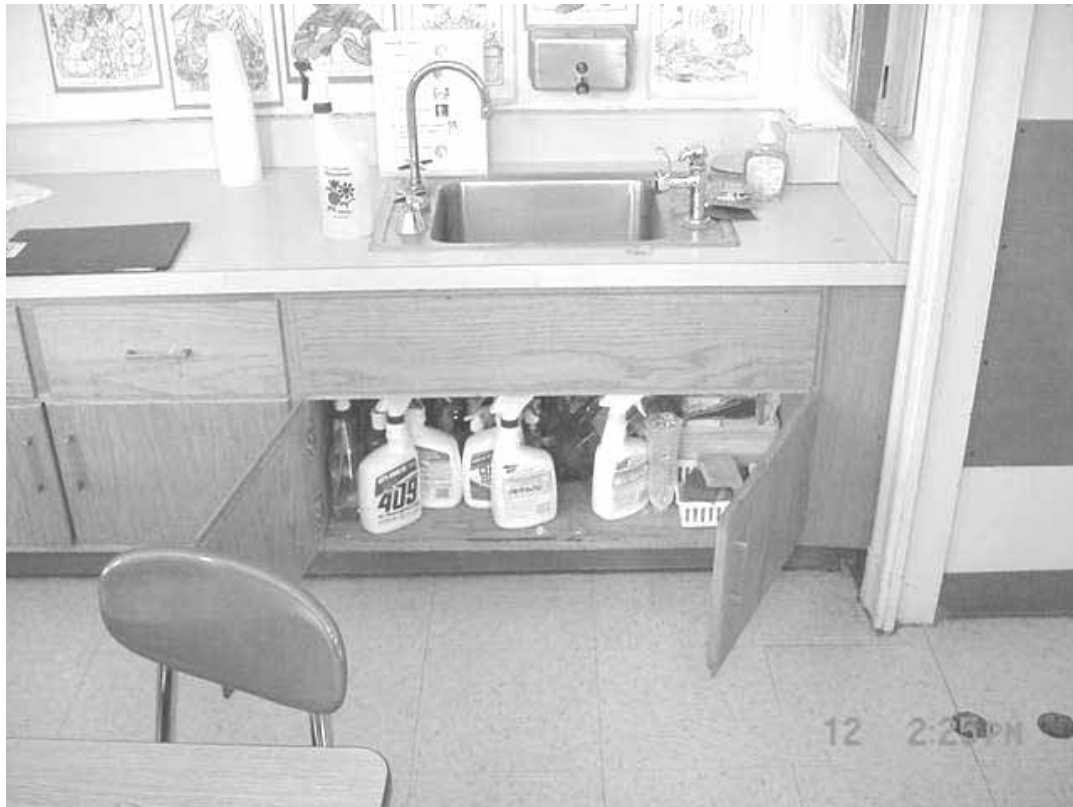
Picture 14

Cleaning products were found in unlocked cabinets below sinks and on countertops in a number of classrooms (Picture 14). Cleaning products also contain chemicals that can be irritating to the eyes, nose and throat and should be kept out of reach of students.

Unlabeled/poorly labeled spray bottles were also noted. Products should be kept in their original containers, or should be clearly labeled as to their contents, for identification purposes in the event of an emergency.

Spray Cleaning Products in Unlocked Cabinet and on Countertop in Classroom

16. Store cleaning products properly and out of reach of students. Ensure spray bottles are properly labeled in case of emergency.
